## TECHNICAL INFORMATION BULLETIN

**DrivePack DPDA  
Input Module Modification**

NUMBER: TB- 053

DATE: 06/08/2012

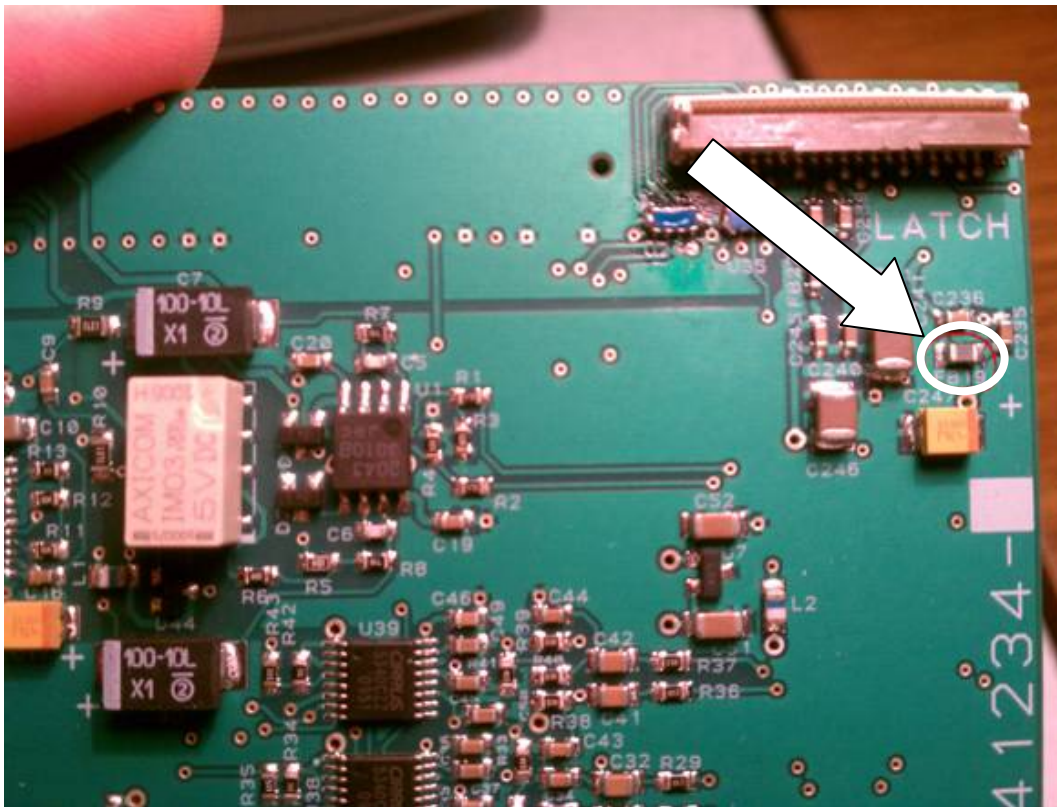
**Fig.1 Location of FB19 on middle board**

These changes prevent the system from intermittently rebooting and emitting distortion (noise) while in use. The root cause of this issue involve extreme current draw from the DSP exhausting the regulated supply and causing increased dissipated heat.

1. Remove the (2) T-15 Torx screws that hold down the top board (PWA-141213).
2. Remove the top board to access the middle board, **PWA 141234-5 or earlier**.
3. Locate FB19 & FB13 on the middle board as indicated in Fig.1 & Fig. 2. Replace FB19 & FB 13 with a higher current part (JBL part number 141686-1JBL).
4. Locate R96 on the top board as indicated in Fig.3. With **PWA 141213-6 or earlier**, replace R96 with 10.5k (Part Number 141212-5jbl). With **PWA 141213-7 or PWA 141213-8**, replace R96 with 9.76k (Part Number 141212-6jbl).
5. Reassemble the input module and test/confirm proper operation.

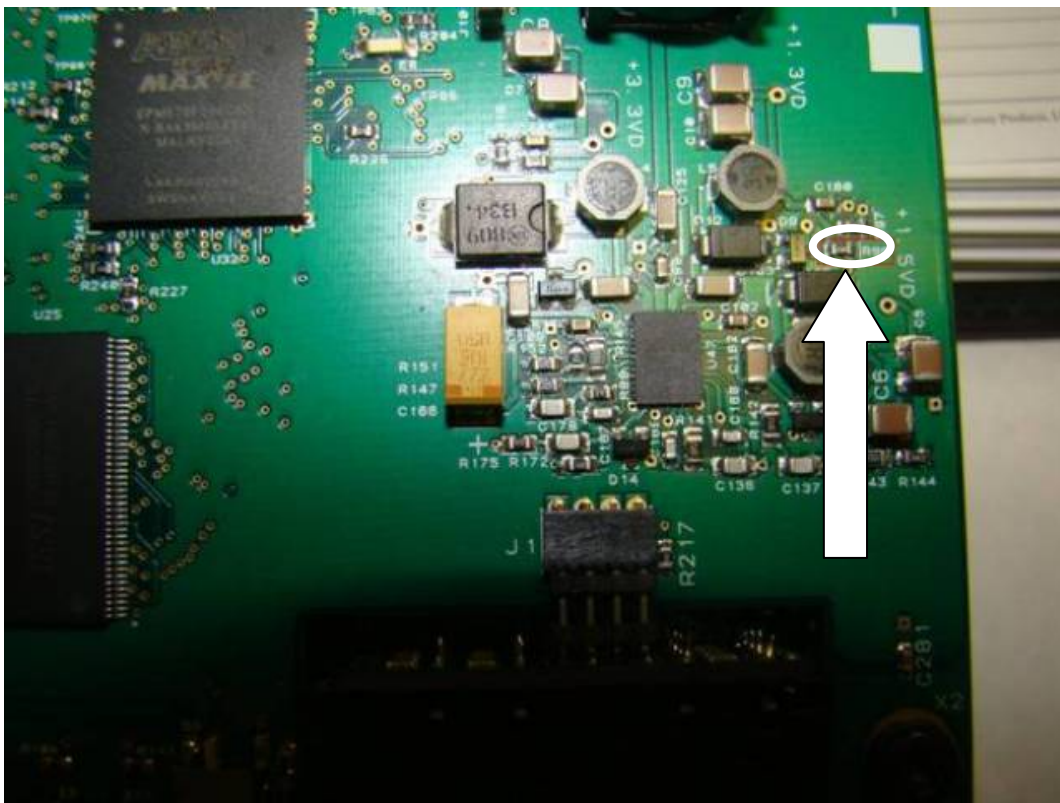
Fig.3 Location of R96 on top board

The resistor change further assists managing current flow to the DSP. PWAs 141234-5 or earlier had a thinner trace coming off of the regulator that feeds the DSP. These boards require the largest value resistance to account for this thinner trace. PWAs 141213-7 and -8 have the thicker trace present but still need an increase in resistor value to clear up the majority of rebooting problems. After these changes have been made, V4 or V5 tunings can be run with minimal likelihood of difficulty.
